LTI460AA04 Handling Guide

LCD Business
Samsung Electronics Co., Ltd.

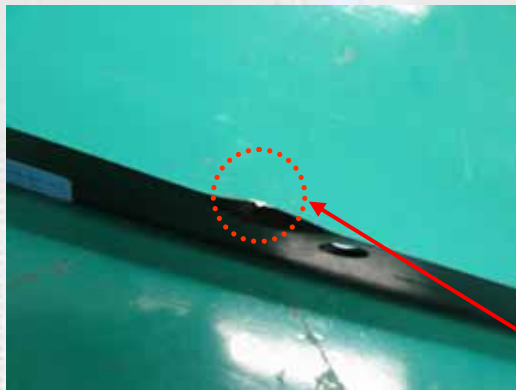
- Glass broken
- Line defect caused by Driver IC Lead crack
- Top chassis damage such as bending and scratch.

Damaged Top Chassis

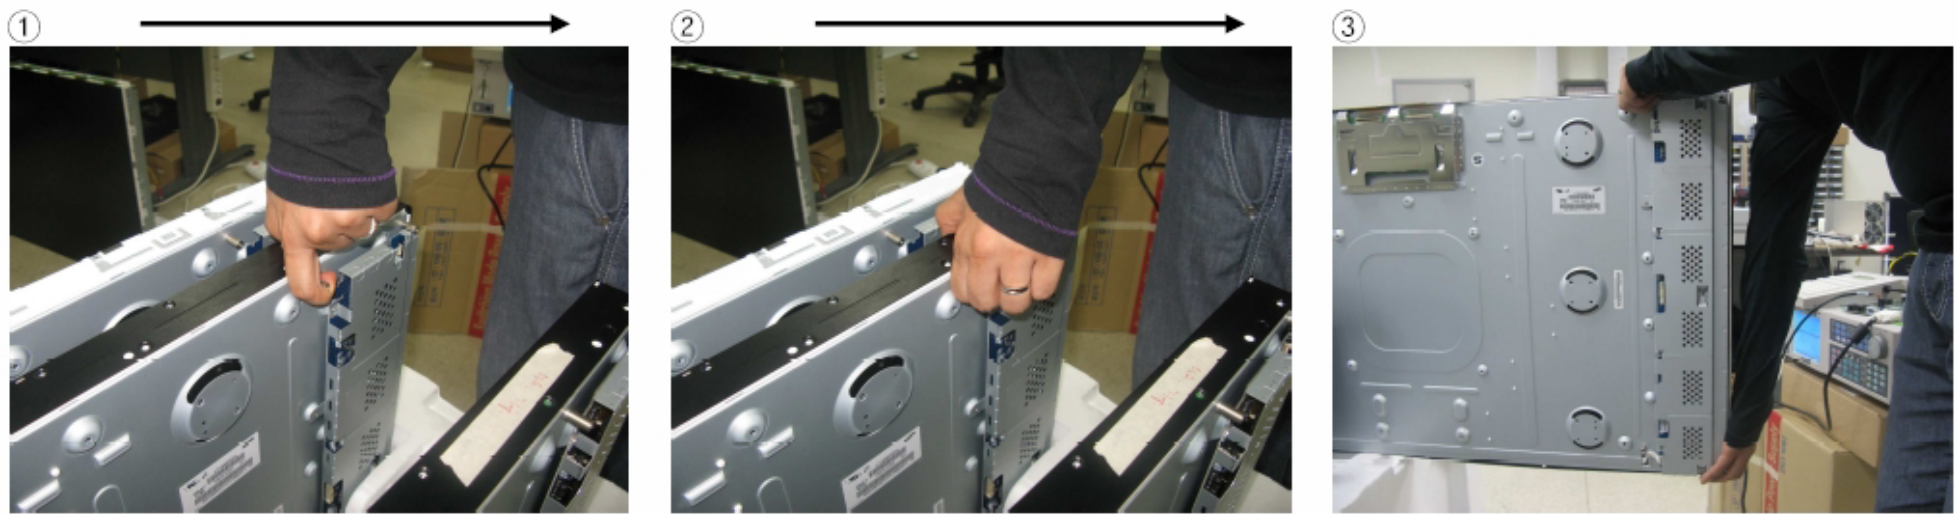
- Protect LCD module from external shock and vibration during transportation.
- Keep handling method and procedure as below picture.
